## 一起220 kV变压器铁心故障的判断与分析

### Treatment and Analysis on a Core Fault in 220 kV Transformer

某 220 kV 变电所 2 号主变, 型号为 SFSZ11-

180000/220, 密封式结构, 铁心通过套管从油箱上部引出可靠接地, 结构件通过油箱可靠接地<sup>[5]</sup>。该变压器 2009 年 9 月制造, 经现场交接试验合格后于 2010 年 7 月 26 日空载投入运行。2010 年 12 月 17 日带负荷运行, 例行油样色谱分析中发现油中特征气体有异常, 接着又出现乙炔(C<sub>2</sub>H<sub>2</sub>), 虽未达到注意值, 但说明存在由低能放电发展成高能放电的可能, 怀疑变压器内部存在缺陷<sup>[6-10]</sup>。跟踪数据见表 1。

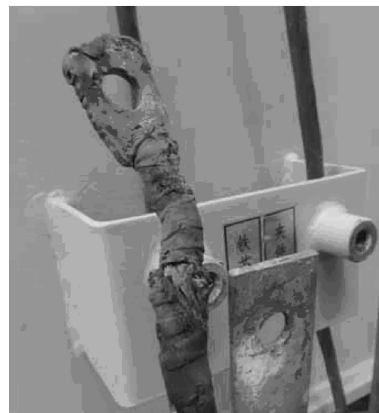
当测试铁心绝缘电阻时发现铁心接地引下线与接地带处螺丝松动,拆引后发现接头连片烧损,见图1。

铁心接地引下线与接地带处螺丝松动,接头连

图1 铁心接地引下线靠近接地端子处绝缘护套烧损情况

片及连线已经烧损,这是导致色谱数据异常的直接原因。

由于铁心接地引下线与接地带处螺丝松动离异,铁心产生悬浮电位,当电位、能量积累到一定程度时产生悬浮电位放电,放电时,铁心接地,悬浮电位消失,放电停止后,悬浮电位又出现,如此使铁心中积累的能量不断的通过悬浮电位放电经接地引下线泄入大地。

放电的能量决定于接地引下线与螺丝离异程度,离异的距离越大放电的能量越大,如上述分析可知,故障性质为高温兼放电性事故(远远大于局部放电的能量),放电的能量来源于两个方面:一是正常负载的磁通在铁心接地铜片和接地引线的磁滞和涡流损耗,与所带负荷有一定的关系,该损耗对总损耗的影响不大;二是由于螺丝松动离异,导使铁心产生悬浮电位,造成两点之间放电,放电产生的电流在铁心接地铜片和接地引线上产生有功损耗,该损耗起决定性作用,决定事故的性质。

更换接地引线,由于没有对变压器油进行处理,油色谱数据保持不变,见表2。
